**DEPARTMENT OF TRANSPORTATION****DIVISION OF ENGINEERING SERVICES**

Quality Assurance and Source Inspection

Contract #: 04-0120F4Cty: SF/ALA Rte: 80 PM: 13.2/13.9File #: 1.28**WELDING INSPECTION REPORT****Resident Engineer:**Siegenthaler, Peter**Address:** 333 Burma Road**City:** Oakland, CA 94607**Report No:** WIR-024424**Date Inspected:** 13-Jun-2011**Project Name:** SAS Superstructure**OSM Arrival Time:** 700**Prime Contractor:** American Bridge/Fluor Enterprises, a JV**OSM Departure Time:** 1730**Contractor:** American Bridge/Fluor Enterprises, a JV**Location:** Job Site**CWI Name:** Pat Swain and Steve Jensen**CWI Present:** Yes No**Inspected CWI report:** Yes No N/A**Rod Oven in Use:** Yes No N/A**Electrode to specification:** Yes No N/A**Weld Procedures Followed:** Yes No N/A**Qualified Welders:** Yes No N/A**Verified Joint Fit-up:** Yes No N/A**Approved Drawings:** Yes No N/A**Approved WPS:** Yes No N/A**Delayed / Cancelled:** Yes No N/A**Bridge No:** 34-0006**Component:** SAS Tower**Summary of Items Observed:**

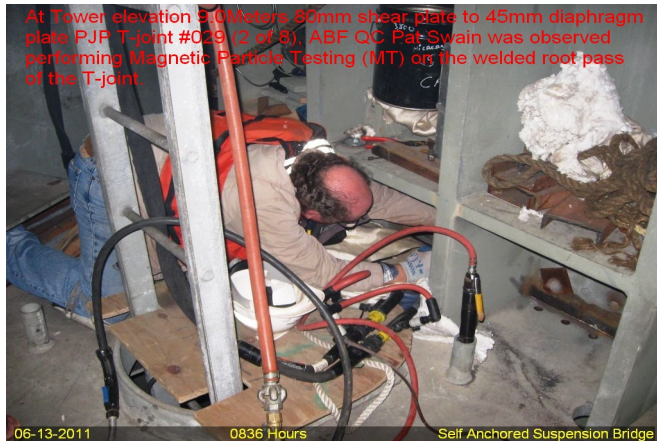
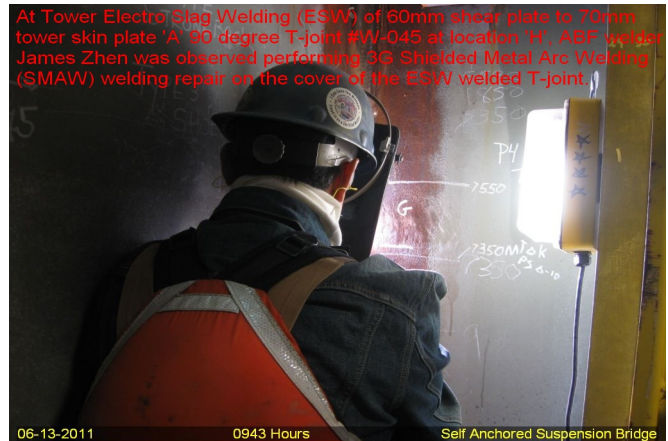
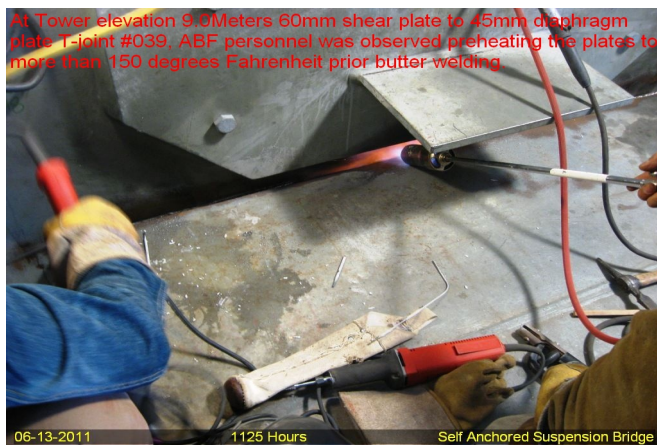
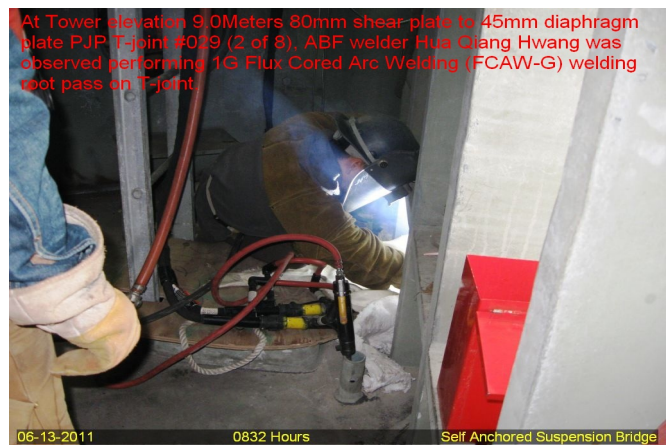
At Tower Base Shear Plate (80mm) to Diaphragm Plate (45mm) weld joint #029 (2 of 8), this QA Inspector randomly observed ABF personnel Hua Qiang Hwang continuing to perform production 1G welding on the Partial Joint Penetration (PJP) of T-joint between the 80mm thick shear plate and 45mm thick diaphragm plate. The welder was using the dual shielded Flux Cored Arc Welding (FCAW-G) with E71T-1M, 1/16" diameter wire electrode and implementing Caltrans approved Welding Procedure Specification (WPS) ABF-WPS-D15-3160-1. This QA Inspector observed ABF personnel using Miller Proheat 35 Induction Heating System to preheat the plates being welded prior to and after welding. This QA Inspector observed QC Inspector Pat Swain using a Fluke infra red temperature gauge to verify the preheat temperature of more than 325°F. This QA Inspector performed a verification of the welding parameters and observed 280 amperes and 23.9 volts with a travel speed of 550 mm per minute with equivalent heat input of 0.73 Kj per mm. The welding appeared to comply with Welding Procedure Specification (WPS) ABF-WPS-D15-3160-1. During the shift, the welder has completed the PJP weld joint and right after the completion of the weld joint, ABF personnel were noted covering the weld with heater blanket in preparation for the three hours holding of preheat temperature of more than 325°F as required. ABF personnel were using Miller Proheat 35 Induction Heating System to hold the preheat that was programmed to shut off after three hours.

At Tower Base South Shaft, weld number W-045 of location 'H', ABF welder Han Wen Yu was observed 3G Shielded Metal Arc Welding (SMAW) welding cover repair on this Electro Slag Welding (ESW) welded T-joint. The welder was noted using 1/8" diameter E7018H4R electrode implementing Caltrans approved ABF-WPS-D15-1000 repair. The welder was noted preheating the excavated weld cover to more than 300 °F using propylene gas torch. Location of the repair being welded was noted at Y=7350mm to Y=7550mm. ABF QC Pat Swain was noted monitoring the parameters of the welder. At the end of the shift, repair welding of the weld cover mentioned above was completed.

At South (C-D) corner, upper splice plate; This QA Inspector randomly observed ABF welding personnel Xiao Jian Wan continuing to perform production welding on the top half of the upper splice plate using the self shielded Flux Cored Arc Welding (FCAW) process with 1.8mm diameter E71T-8 wire electrode implementing Caltrans approved (WPS) ABF-WPS-D15-F2200-3. The welder was noted 3F (vertical) fillet welding the splice plate to interior corner closure plate of the tower shaft. This QA Inspector observed ABF personnel using a propylene gas torch to preheat the plates to be welded prior to welding. This QA Inspector observed QC Inspector Steve Jensen using a Fluke infra red temperature gauge to verify the preheat temperature of more than 300°F. The welding appeared to comply with Welding Procedure Specification (WPS) ABF-WPS-D15-F2200-3. At the end of the shift, vertical fillet welding was still continuing and should remain tomorrow. ABF personnel were noted covering the weld with heater blanket in preparation for the three hours holding of preheat temperature of more than 300°F as required. ABF personnel were using Miller Proheat 35 Induction Heating System to hold the preheat that was programmed to shut off after three hours.

At West (B-C) corner, upper splice plate; This QA Inspector randomly observed ABF welding personnel Salvador Sandoval continuing to perform production welding on the bottom half of the upper splice plate using the self shielded Flux Cored Arc Welding (FCAW) process with 1.8mm diameter E71T-8 wire electrode implementing Caltrans approved (WPS) ABF-WPS-D15-F2200-3. The welder was noted 3F (vertical) fillet welding the splice plate to interior corner closure plate of the tower shaft. This QA Inspector observed ABF personnel using a propylene gas torch to preheat the plates to be welded prior to welding. This QA Inspector observed QC Inspector Steve Jensen using a Fluke infra red temperature gauge to verify the preheat temperature of more than 300°F. The welding appeared to comply with Welding Procedure Specification (WPS) ABF-WPS-D15-F2200-3. At the end of the shift, vertical fillet welding was still continuing and should remain tomorrow. ABF personnel were noted covering the weld with heater blanket in preparation for the three hours holding of preheat temperature of more than 300°F as required. ABF personnel were using Miller Proheat 35 Induction Heating System to hold the preheat that was programmed to shut off after three hours.
